hemming the way: our un-tethered pavements

POWER OF SEEING

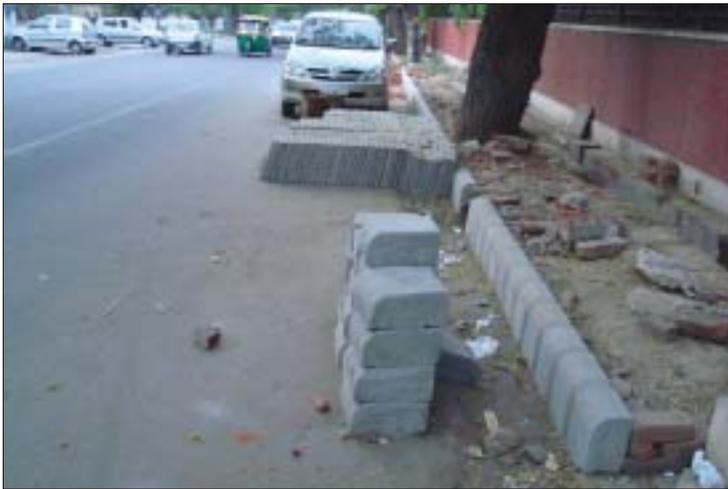
Example of blocks placed without preparing ground or applying any adhering treatment to secure them to the ground

- First and most basic omission lies in the fact that these blocks are simply placed on the ground without applying any adhering treatment that would anchor them.
- In the second example, we revisit a pavement where the tarmac did not bleed to the edge of the carriage way, thus supporting against the base of the asphalt blocks, reinforcing them.

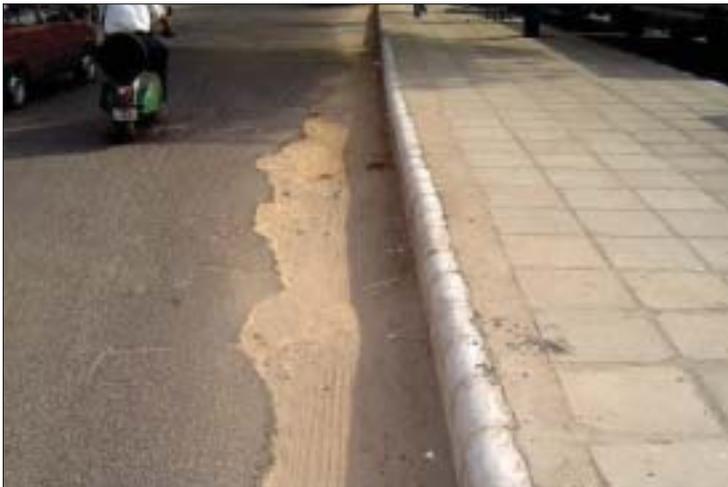
April 2006: The tarmac on the road is not laid evenly to bleed to the edge so as to reinforce the side of the pavement

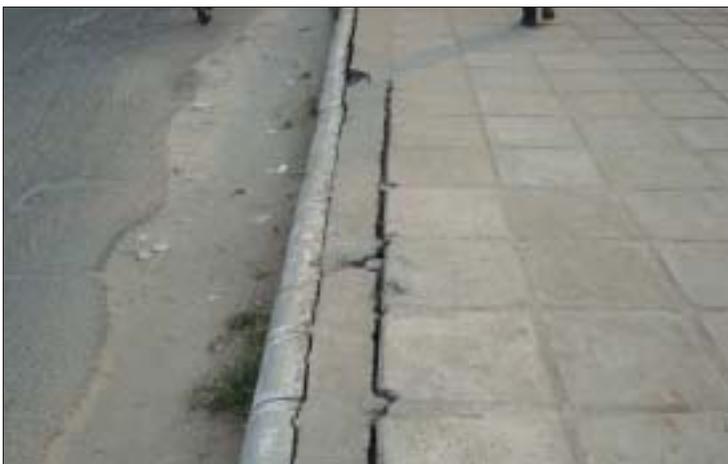
November 2007: In time, the unsupported blocks begin to gradually fall, resulting in cracks on the top of the pavement

Sure enough, as suspected, within a year, we see a wide crack developing at the top (there are other reasons too that result in these cracks, but we will address them in later articles as they do not pertain to the current focus of adhering the blocks to the ground).

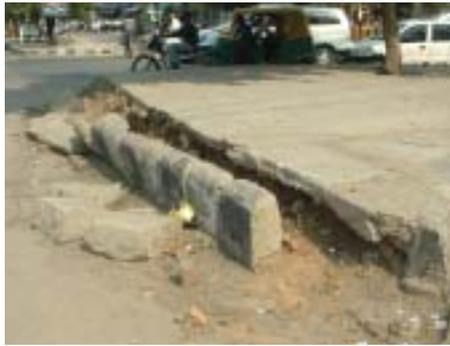
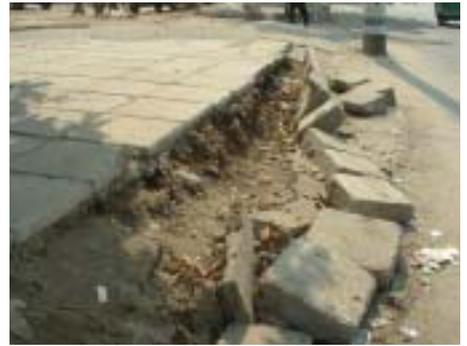
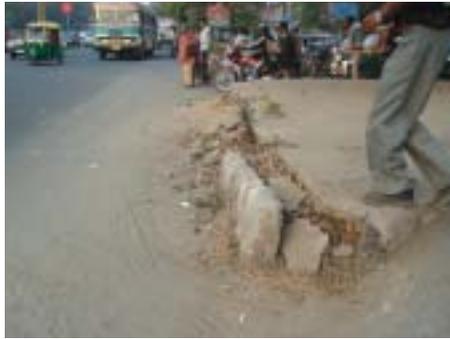
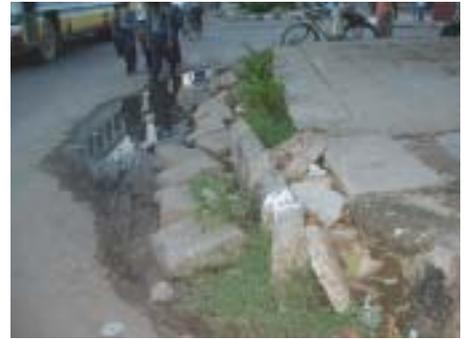
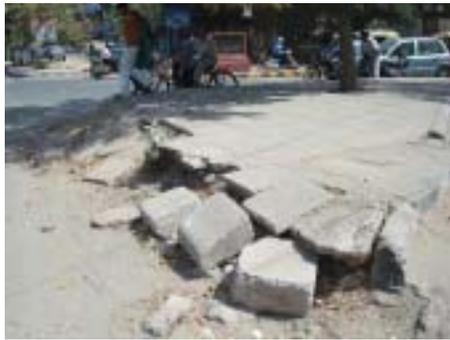
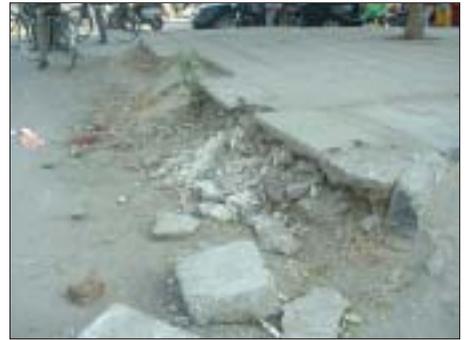
Photo document of an edge of a pavement on Aurobindo Marg that has been slowly falling apart over the last two years, littering the road with cement blocks

- The third example documents a dramatic falling apart of a pavement. In two years, since the pavement was constructed, its edge has completely come off.
