# mind the gap: tool apathy and the lack of definition on our roads

## POWER OF SEEING

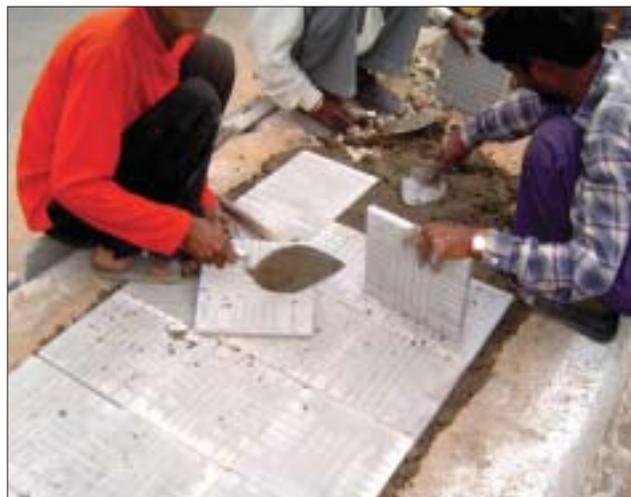
*Trowel, a plastering tool, poised to break a tile into two*

We followed the history of one pavement from repair to disrepair. The pavement was being retiled and this required cutting some tiles into smaller pieces to fit the frame of the pavement. The tiles were well designed and looked sturdy; however, the workers were not equipped with any cutting tools. They used their ingenuity and used a plastering trowel to break the tiles to approximate size. Even though they were being careful, the edges of many tiles were far from even, making the interlocking between tiles impossible. Within months, the whole pavement came apart, completely unravelled! It is of course due to various other reasons as well that this pavement broke, but one of them was use of inaccurate tools.

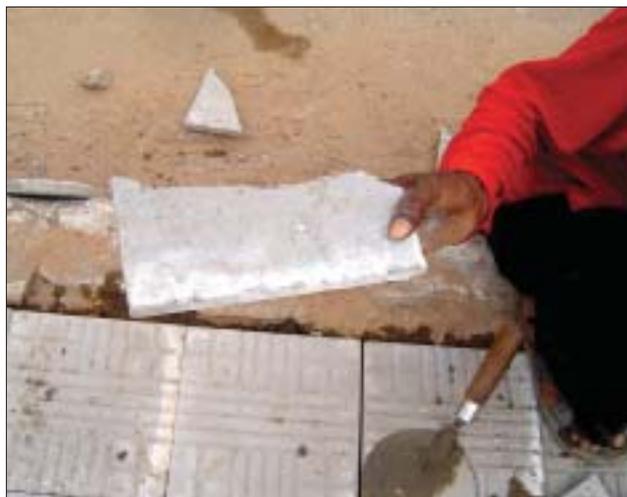
*Uneven edge of paving tile broken with inappropriate tool*

determine the quality of the pavement. If the edges are not evenly cut, they will result in an ill-defined edge of the pavement making the sealing of the edge more difficult; secondly, they will not tightly interlock into the grid of tiles. In both these cases, they would be more susceptible to come loose and in time, result in the unravelling of the pavement.

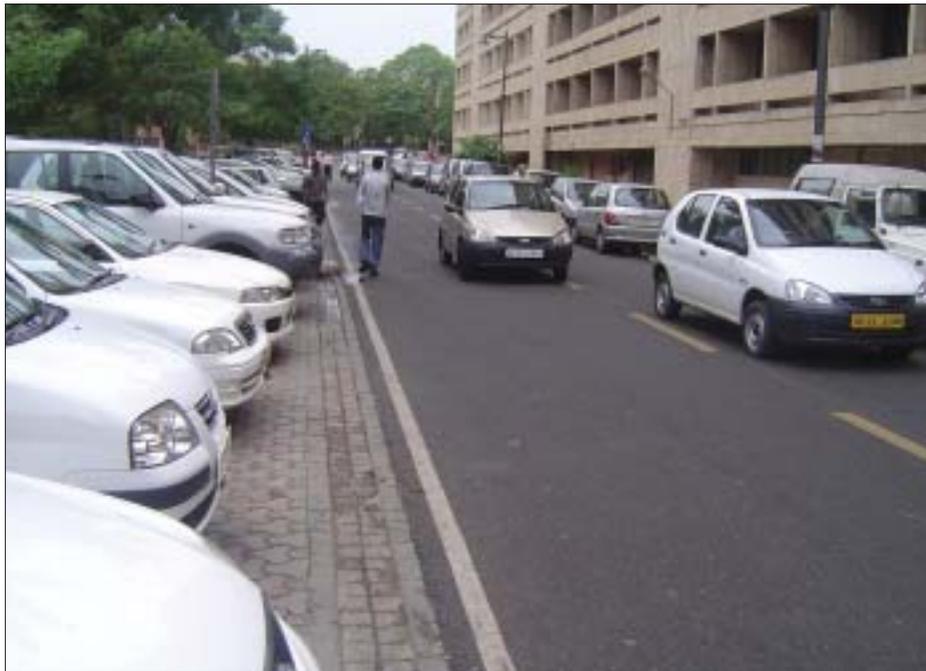
A well demarcated space at Bhikaji Cama Place that dictates order on the street

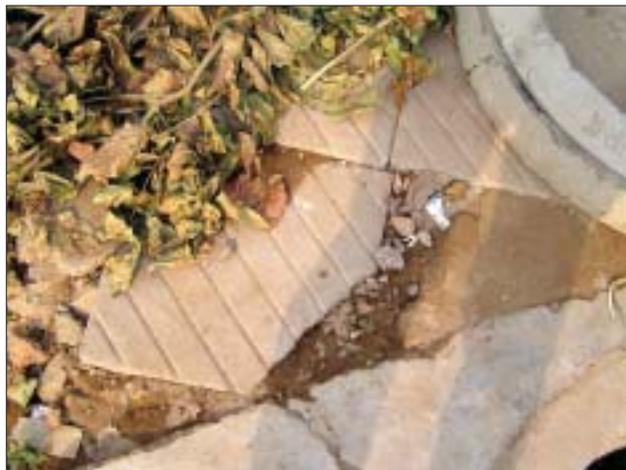
Close up of an unevenly cut tile that is not secured and hence can come off

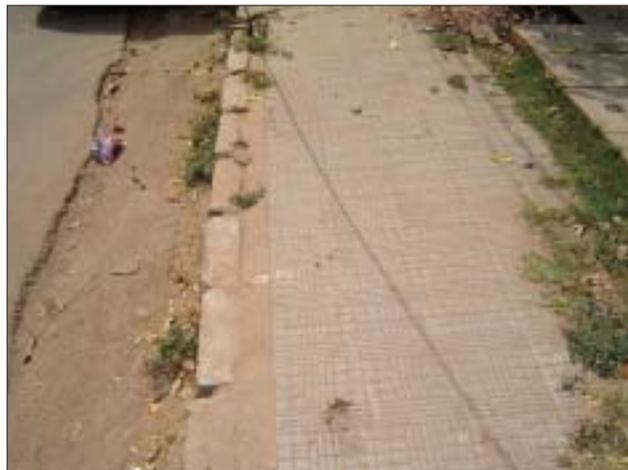
A gap left between edge of pavement and tiled area as tiles could not be cut to size

In other cases, when cutting a tile to exact size is not possible, the margins are left un-tiled and sometimes even unplastered, leaving the pavement exposed to the elements and more susceptible to quicker wear and tear!
